FINAL EXAM

1: For the Final Exam I will be analyzing Wakulla Springs. Wakulla Springs is located near Tallahassee, Florida.

3. Spring restoration assessment plan – Wakulla Springs

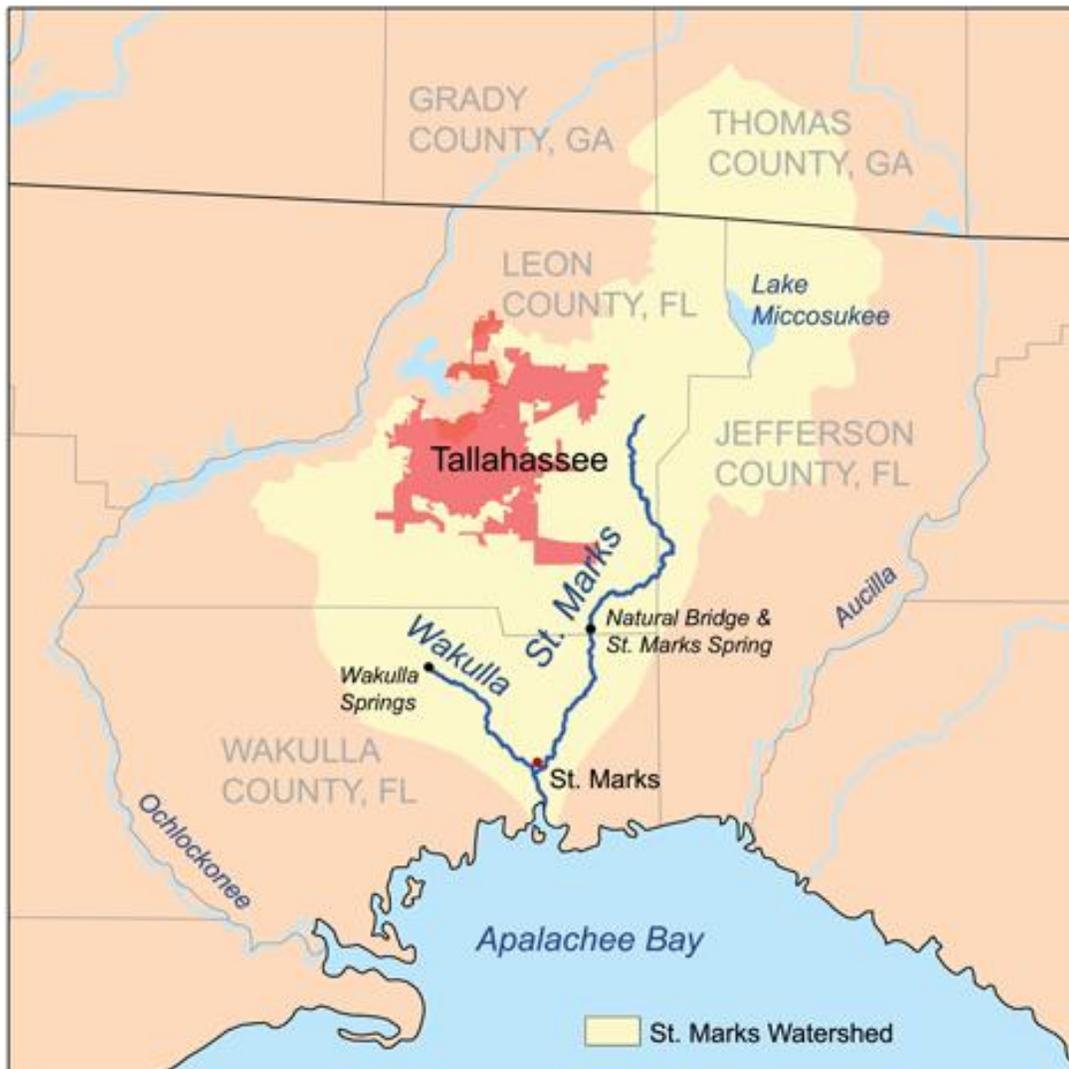
Image 5: Wakulla and St Marks River Map (Musser, 2012)

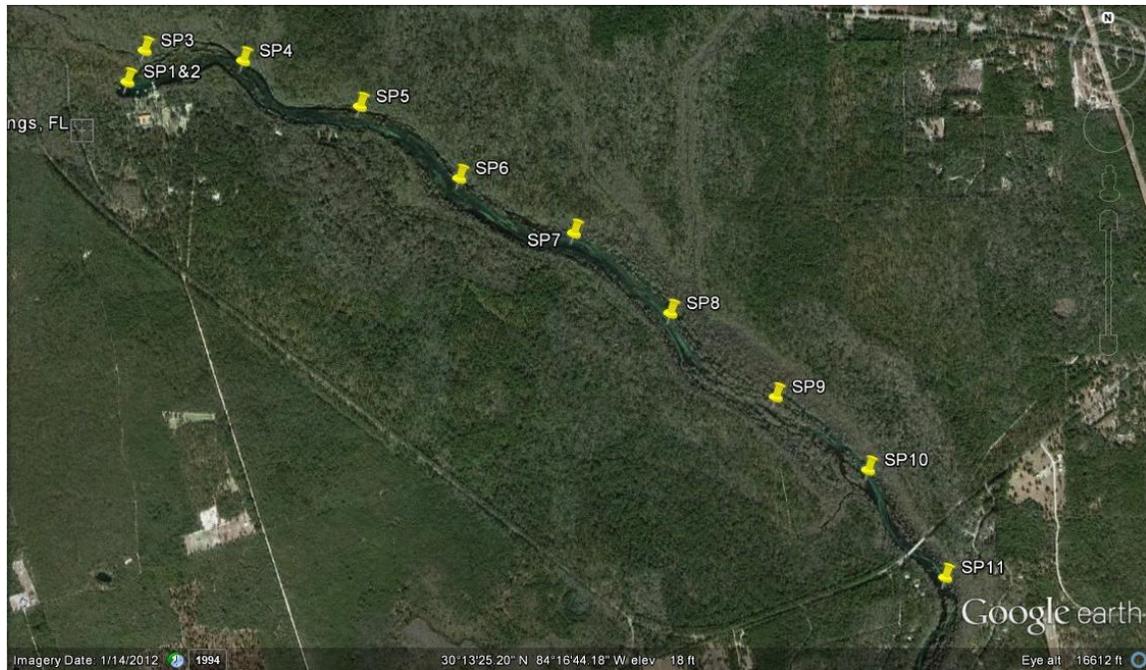
Image 6: Wakulla Springs Sampling Locations (google earth, 12-08-12)

Sampling locations are of major importance. Since most of the nitrate sources are related to contributions applied to the land within the springshed the nitrate concentrations should be measured as close to the spring boil as possible. This is intended to measure Since Wakulla Spring has such a large cave at the spring boil, the opportunity to sample in the cave is a unique opportunity. Sampling locations (SP1-2) are proposed at the mouth of the cave and approximately 100 feet deep into the cave. Data from these two sampling points should indicate the nitrate levels emerging from the aquifer. The plan also includes sample points (SP4-11) spaced at approximately 2000 feet down the spring run. These sample points should be able to indicate the rate of de-nitrification down the spring run. One additional sample point (SP3) is located at the confluence of the Sally Ward Spring Run and the Wakulla Spring run to isolate the contributions of the Sally Ward Spring from the system.

The goal of this sampling layout will be to establish trends in the nitrate levels at the spring and in the spring run. The spacing of the sampling points is intended to indicate the ability of the top part of the spring run to take up nitrogen. Additionally it is intended to allow colorations with mapping efforts of the flora within the spring run to assess the efficiency of varying plant communities down the spring run (see Goal 3).

As part of this plan the spring run illustrated in the sampling map will be divided into 10 segments for analysis. Each segment will be 2,000 feet in length (segments are between sample points) Visual assessment and mapping should be performed on a 6 month reoccurrence interval. And the data should be mapped with a GIS system such as ARCGIS for analysis. Through graphical GIS mapping analysis methods each data set can be overlaid and compared for changes in cover and occurrence of flora. Additionally, the graphical data can correlated with 6 month averages of the nitrate concentrations measured at each sample point.
